Pillow block on Ball Mill

Make: **SKF**

Model: **SNL 3164, 300mm shaft**

Industry: **Aluminum Smelting**

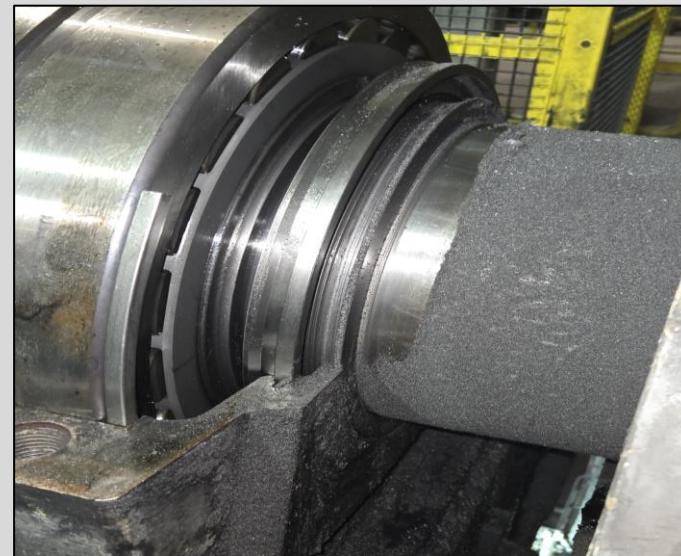
On a ball mill in eastern Canada, aluminum dross was leaking into the pillow blocks driving the large 300mm shaft, causing bearing failure and shaft damage. These issues lead to high maintenance costs, interruption in production due to equipment downtime and safety risk.

Before: Aluminum slag entering the pillow block bearing housing via a faulty taconite seal

A split Inpro/Seal® bearing isolator was installed on the pillow block nearest the leaking aluminum dross to eliminate powder ingress into the bearing housing.

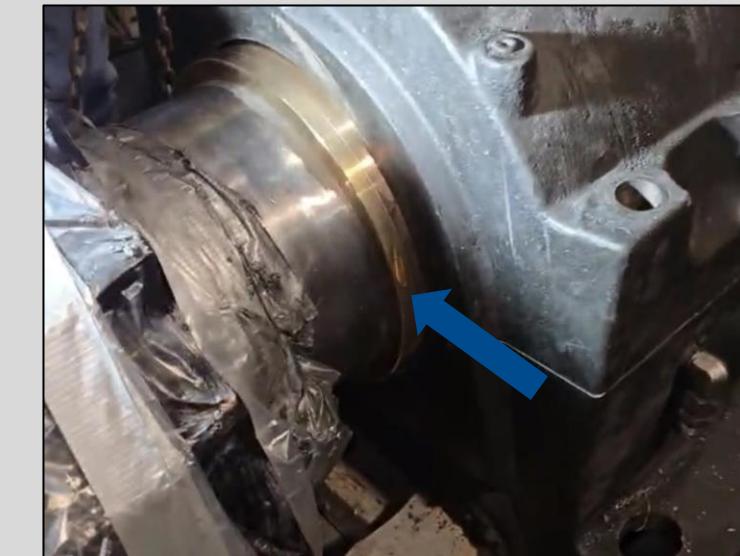
After: Split Inpro/Seal pillow block bearing isolator installed

Shaft damage and premature bearing failure was eliminated. Because the Pillow block does not need to constantly be removed from failure, downtime and maintenance costs have significantly decreased. Due to the success of this seal, equipment maintenance can now be planned and scheduled, and the customer is currently looking to upgrade all other ball mill pillow blocks.

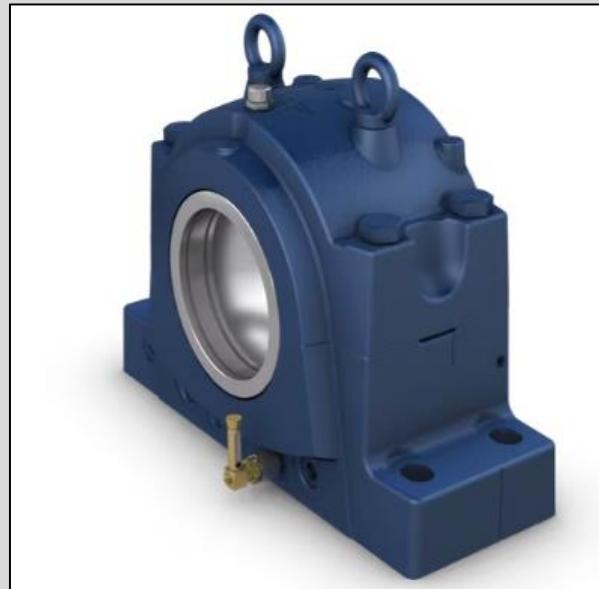
Pillow block application

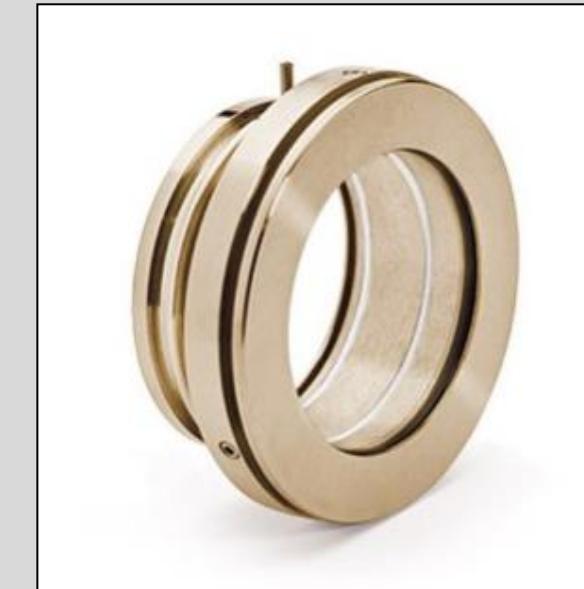
Inpro/Seal pillow block bearing isolator
