# Pillow Block

Model: **SDCD 23176**

Industry: **Mining**

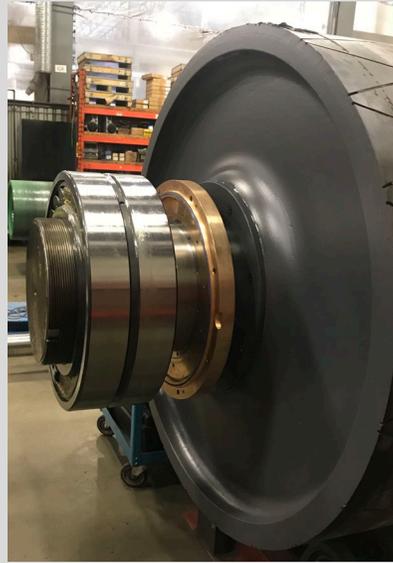
Inpro/Seal Pillow Block Bearing Isolator Installation

Inpro/Seal® Bearing Isolators were installed on the inboard side of the pillow blocks. Inpro/Seal Bearing Isolators are non-contacting compound labyrinth seals with no wearing parts that permanently protect bearings from contamination ingress or lubrication loss. These particular Bearing Isolators were flange mounted for easy installation and utilized an articulating rotor to handle angular misalignment and axial shaft movement.

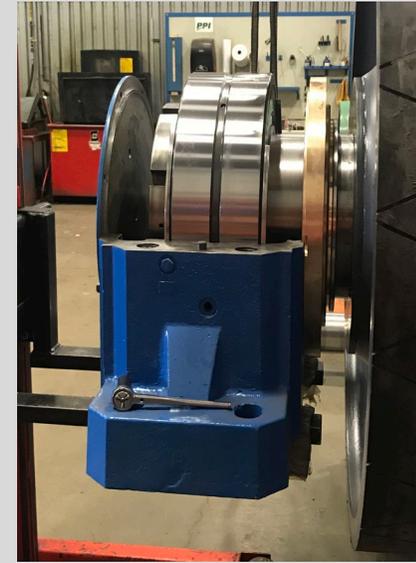
Inpro/Seal Pillow Block Bearing Isolator Installation

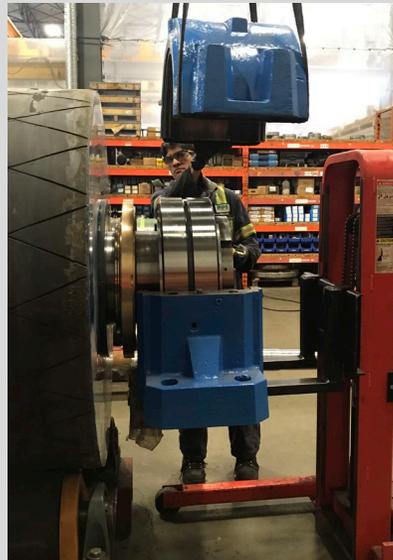
Inpro/Seal Pillow Block Bearing Isolator Installation

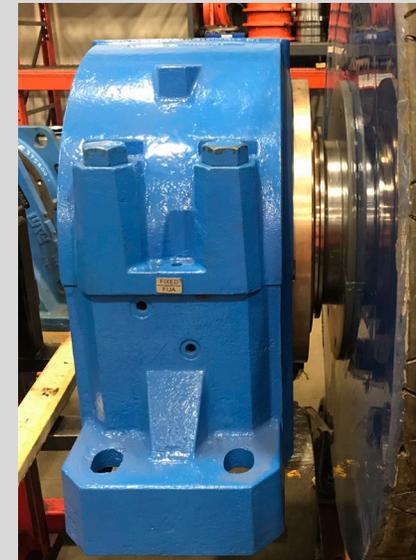
Inpro/Seal Bearing Isolator installed on SDCD 23176 Pillow Block
