Food Processing Pump

Seal Position: **Bearing Frame**

Industry: **Food and Beverage**

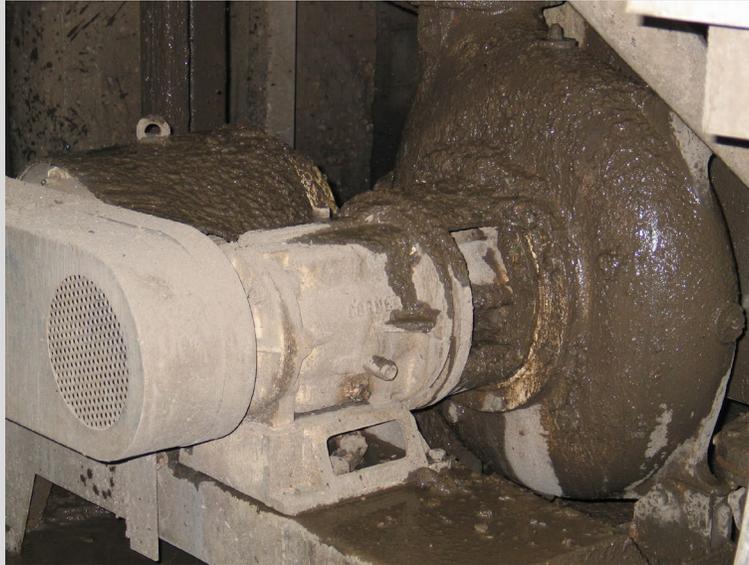
Excessive contamination from the surrounding process and a leaking stuffing box consistently caused premature bearing failure on a food processing pump. The OEM rotary lip seals could not prevent contamination from entering the bearing housing, which caused catastrophic equipment failure in as little as a month.

Significant contamination around this food processing pump challenged bearing life due to constant contamination ingress.

Inpro/Seal Bearing Isolators were installed on both ends of the bearing frame. The Inpro/Seal Bearing Isolator is a non-contacting bearing seal that permanently protects against contamination ingress and lubrication loss. Due to its non-contacting design, the Inpro/Seal Bearing Isolator has no wearing parts, lasting the lifetime of the equipment.

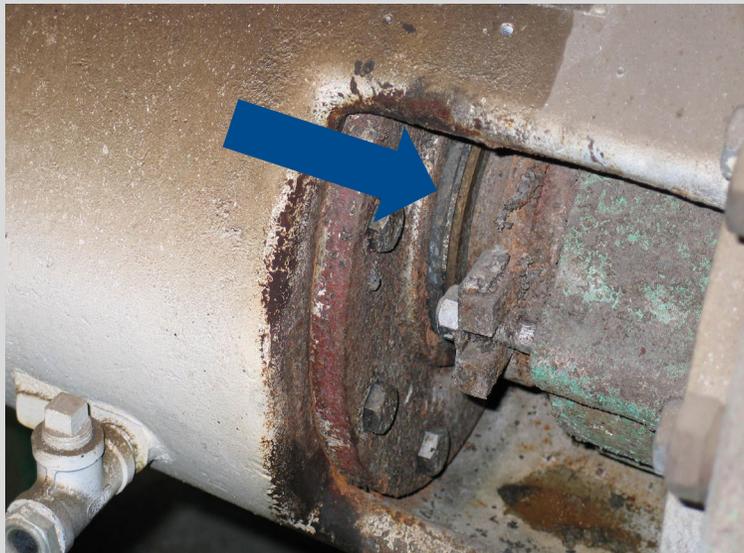
An installed Inpro/Seal Bearing Isolator in service for multiple years still performing with no issue.

Bearing frame life increased to over two years and running. Due to the increased performance on their pump bearing frames, the plant has targeted additional assets for Inpro/Seal Bearing Isolator upgrades.
