CASE STUDY

Sentinel® FBS | Process Steam Turbines

GUARDING AGAINST DAMAGE AND LEAKAGE: THE SENTINEL® FLOATING BRUSH SEAL IN ACTION

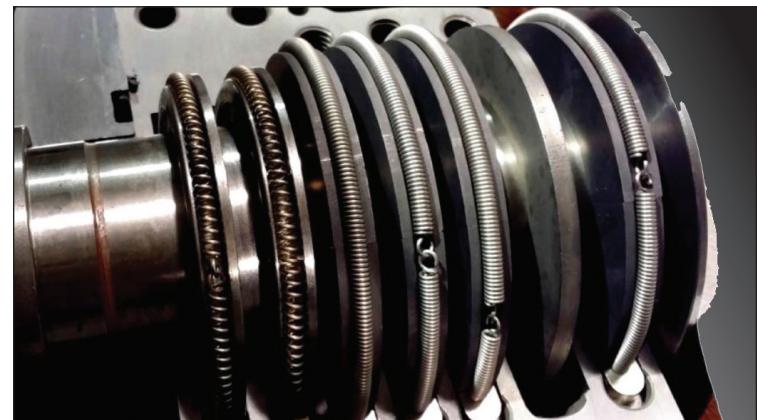
Process steam turbine gland box with Sentinel Floating Brush Seals in the first and second positions (furthest left) and conventional carbon rings in the four remaining positions.

Shortly after the study concluded, the refinery began upgrading its steam turbines with the Sentinel FBS. The Sentinel FBS combines carbon ring face sealing with densely packed bristles that form a compliant contacting seal on the shaft. This brush seal protects downstream carbon rings by filtering out steam contaminants and reducing the pressure profile.

The gland boxes of Unit 1C were upgraded in August 2015 with the Sentinel FBS. Two of the carbon rings in each gland box were replaced with Sentinel FBSs, while the other five carbon rings in each box were replaced with new conventional carbon rings.
