Vertical Tank Agitator

Make: EKATO

Industry: Copper Mining

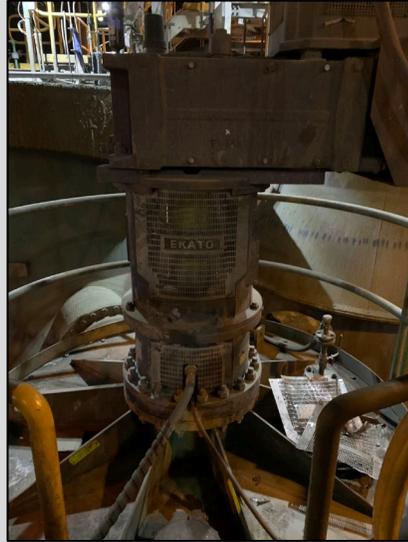
EKATO Vertical Tank Agitator

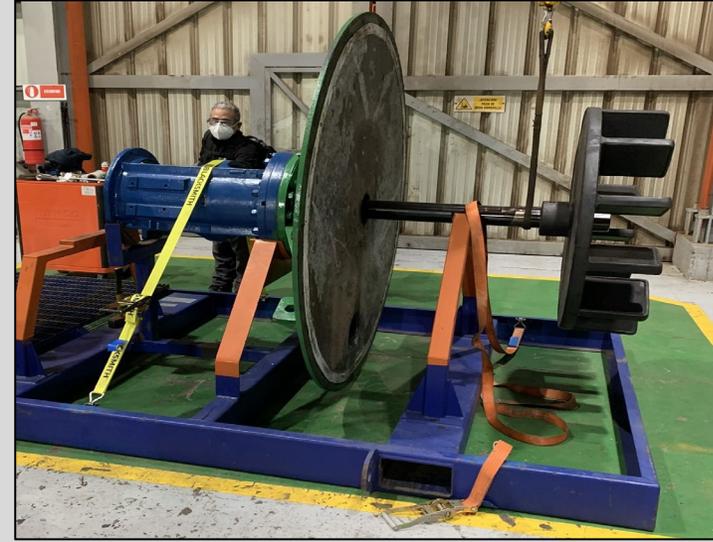
Multiple agitators worked on floatation cells where they agitated a slurry mix to separate the copper minerals. The mine is in the middle of the desert with limited access to water. Due to this, the packing used to seal the vessel would last less than three months as there was no flush water available. This caused the stuffing boxes to leak minerals that were intended for processing. Seal failure led to production stoppage due to equipment downtime, safety risks from product leakage throughout the flotation cells, and loss of fine copper minerals which was costly to the mine.

Vertical tank agitator shaft assembly

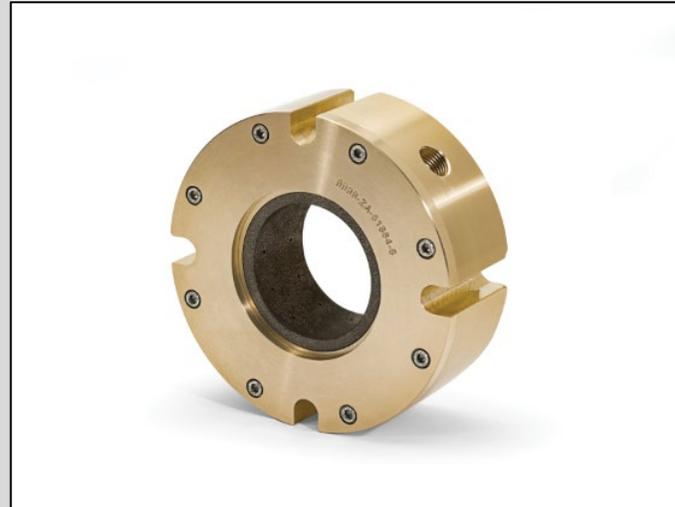
Inpro/Seal Smooth Bore Air Mizer shaft seal

Split Inpro/Seal® Smooth Bore Air Mizer® shaft seals were installed on seven agitators. Air Mizer shaft seals use air to create a barrier on the shaft, permanently sealing against product leakage. Additionally, flush water was no longer needed for these applications. The designs were non-contacting, requiring zero maintenance, and fully articulated to accommodate shaft movement. A split adaptor plate was used to replace the gland packing stuffing boxes on each agitator.

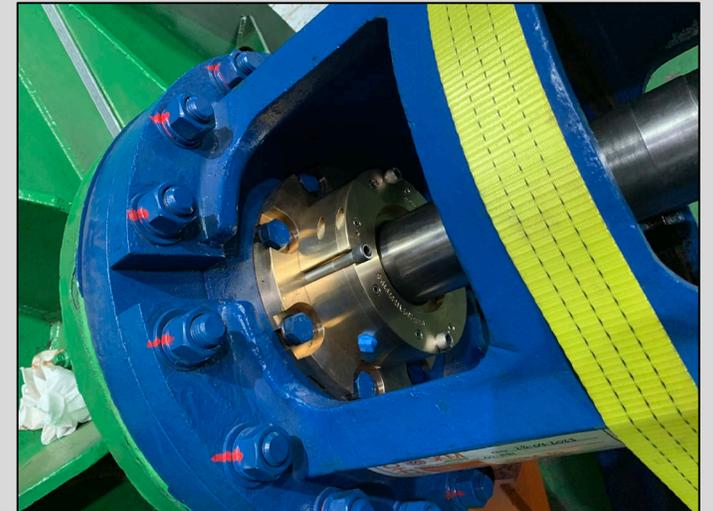
Split Inpro/Seal Smooth Bore Air Mizer shaft seal installed on the vertical tank agitator

All seven seals were installed in 2023 and are currently running without issue, a drastic improvement from the previous three-month MTBF from packing.
