CASE STUDIES: AM FOOD GRADE | RIBBON BLENDER

Increasing Reliability to Ensure a Quality Product

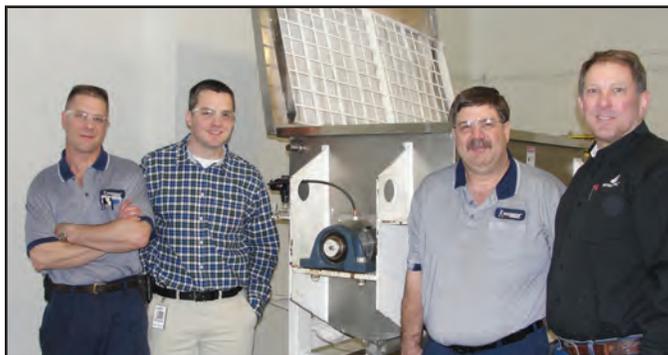
Matt Nicol (right), Inpro/Seal Regional Manager, and Neogen employees stand in front of a newly installed Inpro/Seal® AM Solutions™ shaft seal on one of their ribbon blenders.

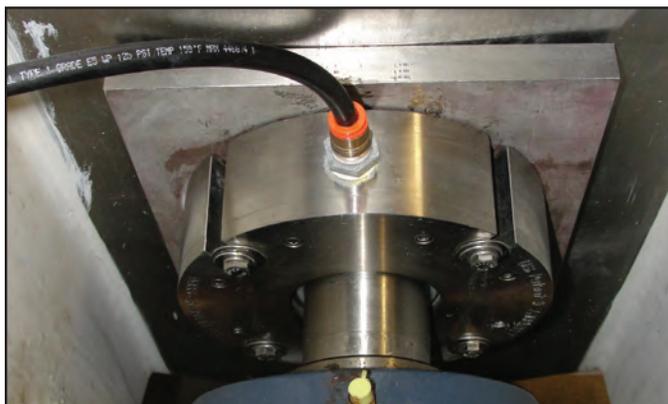
The Inpro/Seal AM Solutions AM Food Grade design is a permanent shaft sealing solution that meets all FDA requirements.

An AM Solutions AM Food Grade design was selected as an optimal solution because it could meet all FDA requirements, withstand the sodium content in the product and meet stringent requirements for the sterile environment. The non-contacting seal utilizes small amounts of air to create a positive purge on the shaft, permanently sealing against product loss and contamination. Unlike mechanical seals, lip seals or packing material, Inpro/Seal AM Solutions shaft seals are able to accommodate for shaft movement, misalignment and/or run-out, and is designed to last the lifetime of the equipment.
