## An Air Mizer™ shaft seal helped Port Townsend Paper solve a long-term bearing contamination problem

# DOING AWAY WITH FAILURE

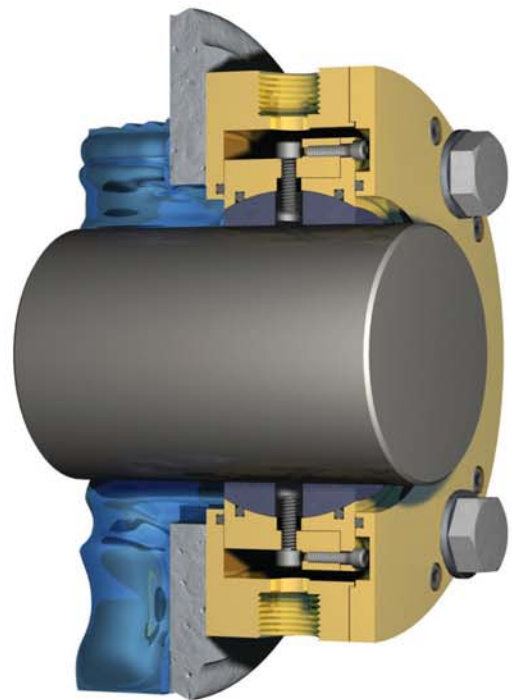
**Inpro/Seal Air Mizer™ Shaft Seal**

Inpro/Seal's bearing isolator is a non-contact, non-wearing labyrinth seal that provides users of rotating equipment with permanent bearing protection. Its two parts – a rotor and a stator – interact with each other to keep contaminants out of a bearing enclosure while keeping lubricant in.

In 1999, following extensive R&D, field testing and laboratory trials, Inpro/Seal unveiled its first shaft seal, the Air Mizer-PS, a modification of its bearing isolator. A compound labyrinth, it was adapted to incorporate an air purge containment system. Its unique design uses a solid wall of air, which functions as a barrier for contamination to retain product where it should be: in the equipment, not outside of it.

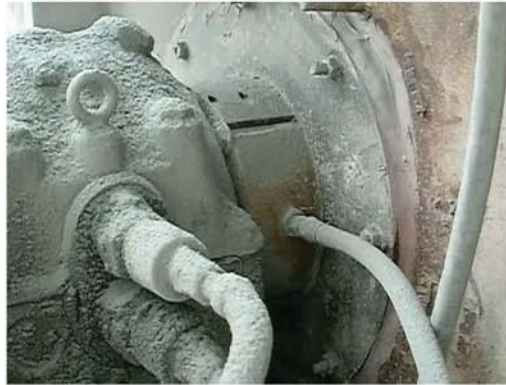
**Fan housing covered in lime dust that was leaking out of the fan housing**

lime dust and the need for a long-lasting means to protect the fan shaft bearing. The bearing assembly for the fan shaft is a hydrodynamic bearing type to accommodate the high heat. Due to the close proximity of the bearing to the fan housing seal and the lack of an effective, long-lasting shaft seal, lime dust would leak through the seal and enter the bearing housing over a relatively short period of time, eventually burying the pillow block in lime dust. Worse, the lime dust was allowed to migrate around to additional equipment (electric motors). In other words, Port Townsend was dealing with an unpredictable 100% failure rate. What they needed was an effective, long-lasting shaft seal that could hold up under their harsh operating conditions.
